REPORT DOCUMENTATION PAGE		READ INSTRUCTIONS BEFORE COMPLETING FORM
1. REPORT NUMBER	2. GOVT ACCESSION NO.	3. RECIPIENT'S CATALOG NUMBER
	AD-A091279	
4. TITLE (and Subtitle) Phase I Inspection Report Lake Welch Dam Hudson River Basin, Rockland County, NY Inventory No. 283		5. TYPE OF REPORT & PERIOD COVERED Phase I Inspection Report National Dam Safety Program

Examination of the available documents and visual inspection of the Lake Welch Dam did not reveal conditions which constitute a hazard to human life or property.

PHASE I INSPECTION REPORT
NATIONAL DAM SAFETY PROGRAM
LAKE WELCH DAM
I.D. NO. N.Y. 283
DEC #196-854
HUDSON RIVER BASIN
ROCKLAND COUNTY, NEW YORK

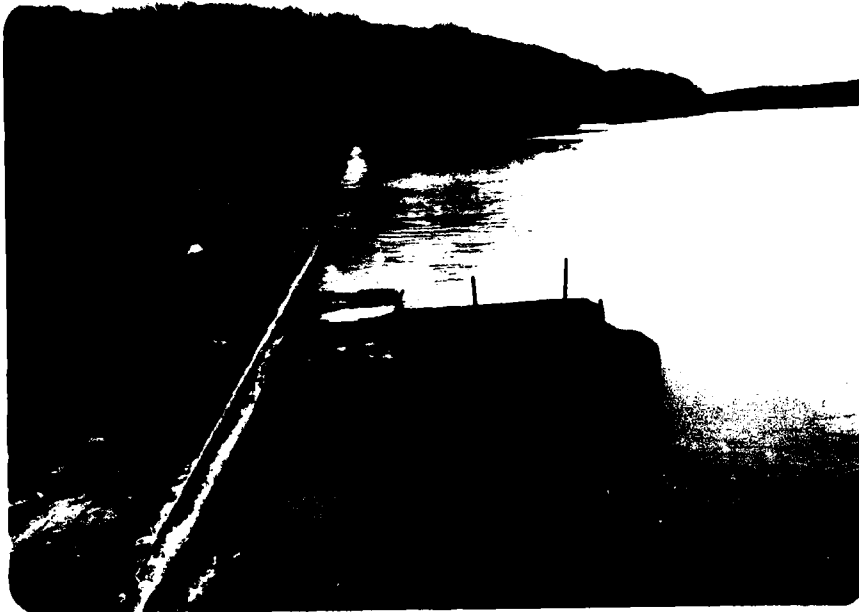
2. VIEW OF CREST OF SPILLWAY AND
INTAKE STRUCTURE FOR HIGH LEVEL
OUTLET.
